CRREL REPORT

95-24

Ground-Penetrating Radar Investigation of the Proposed Dome- CARA Tunnel Route and Utilities at South Pole Station, Antarctica

December 1995

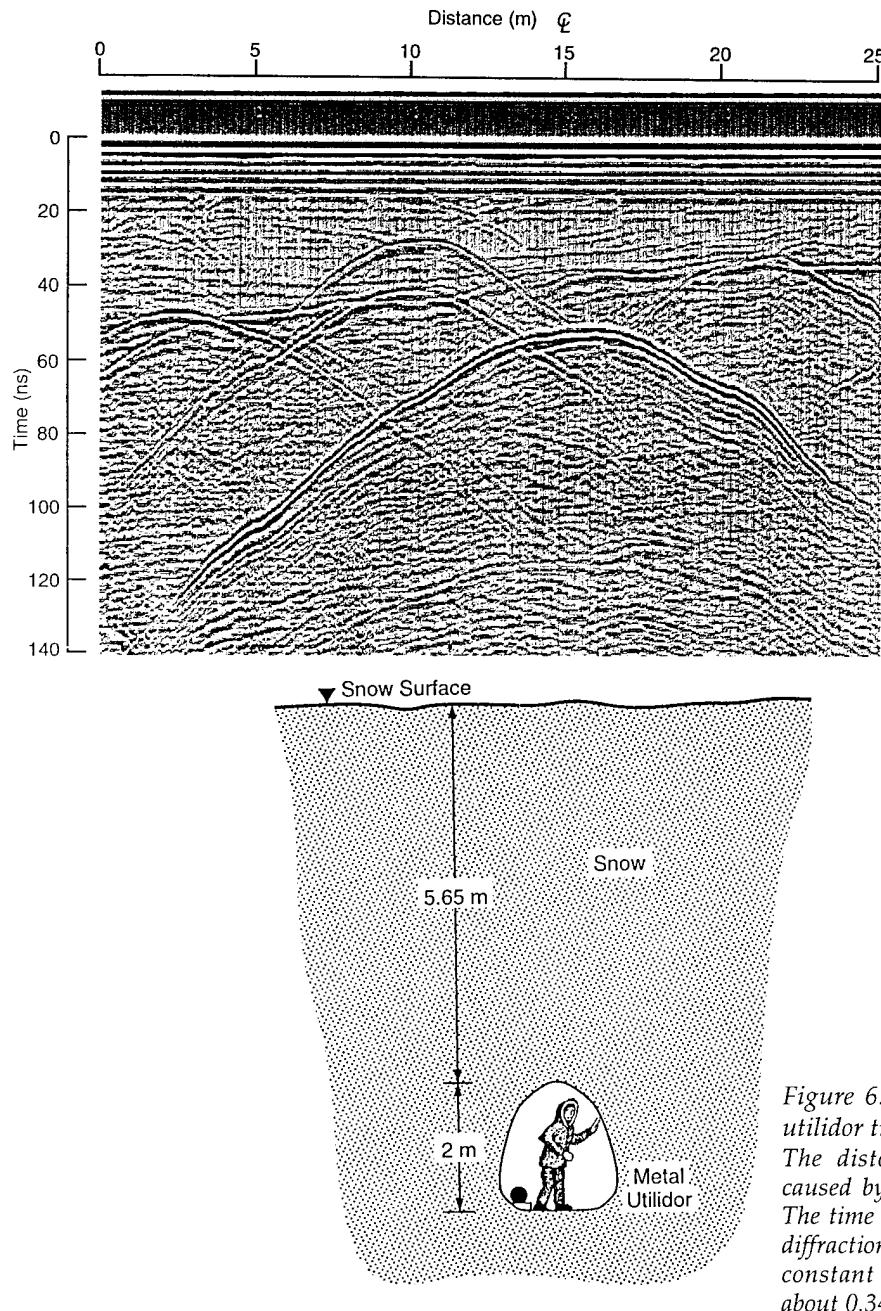
The metal utilidor leading south from the main station (Dome in Fig. 5) was first surveyed (line DE) to establish a calibration value for the snow velocity since the exact depth (5.65 m) from the snow surface to the crown of the metal tunnel was known. The utilidor tunnel itself is 2.0 m high (Fig. 6). Figure 6 also shows the radar profile, acquired with the 400-MHz transducer. The prominent but distorted hyperbolic diffraction under the centerline symbol and whose apex is at 49-ns delay is the response to the utilidor roof. The reflected wavelet at the apex is the large reflection shown in Figure 1. Several other hyperbolas appear in the profile and are generated by buried objects whose depth and placement relative to the vertical plane of the survey line is not

Figure 6. 400-MHz profile of the metal utilidor tunnel along line DE in Figure 5. The distortions in the diffractions are caused by uneven antenna towing speed. The time delay to the utilidor roof and the diffraction itself correspond to a dielectric constant of 1.57 and a snow density of about 0.34 g/cm^3 .

known. The distortions in the diffractions are caused by uneven towing speed. The more uniform left limb of the utilidor diffraction can be matched with a theoretical curve generated with a refractive index $n_m = 1.26$ ($\epsilon = 1.57$), which is close to the values (1.30, 1.69) corresponding to the velocity arrived at using the utilidor depth and time delay. These values correspond to snow density of $0.34\text{--}0.37 \text{ g/cm}^3$ (Cumming 1952) and are slightly less than other values obtained at the South Pole and discussed below.

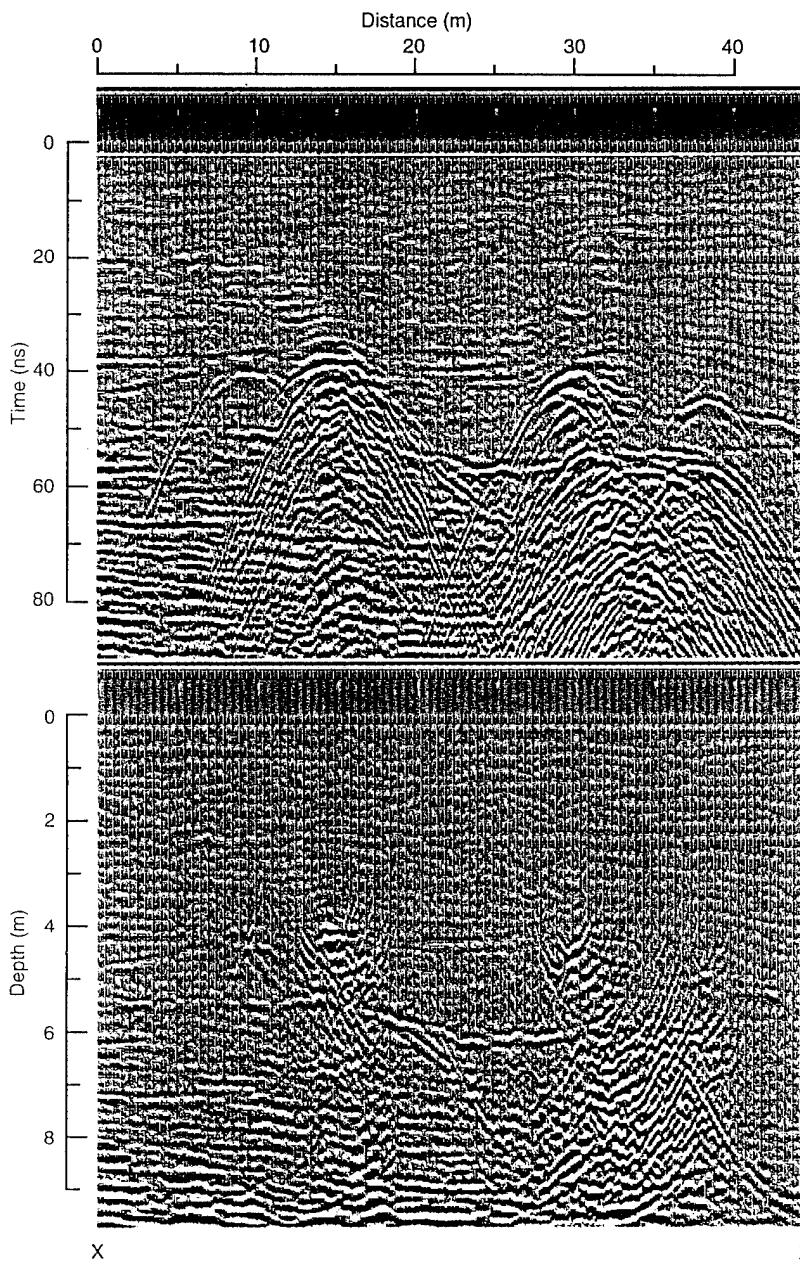
diagonal length = 9.8 m) and, 2) that there are many more diffractions originating at 60 ns towards point Z, suggest that there is more structure buried. The apexes of the prominent diffractions are at about 40 ns and the migrated data resolve these diffractions into two apparent columns. The strong diffraction originating at about 15 m collapses to a horizontal surface (i.e., coherent reflection) about 2 m wide at 4 m depth. The diffraction at 29 m distance also collapses to a coherent reflection at about 4 m depth, but it is not as linear. These diffractions could be responses to metal pipes placed to mark the location of the

Figure 7. 400-MHz profile (top) and its migration along line XZ that crosses the old clean air facility. Many of the diffractions in the top profile have collapsed into discrete events in the migrated section. The linear reflector provides convincing evidence that the building has been located.

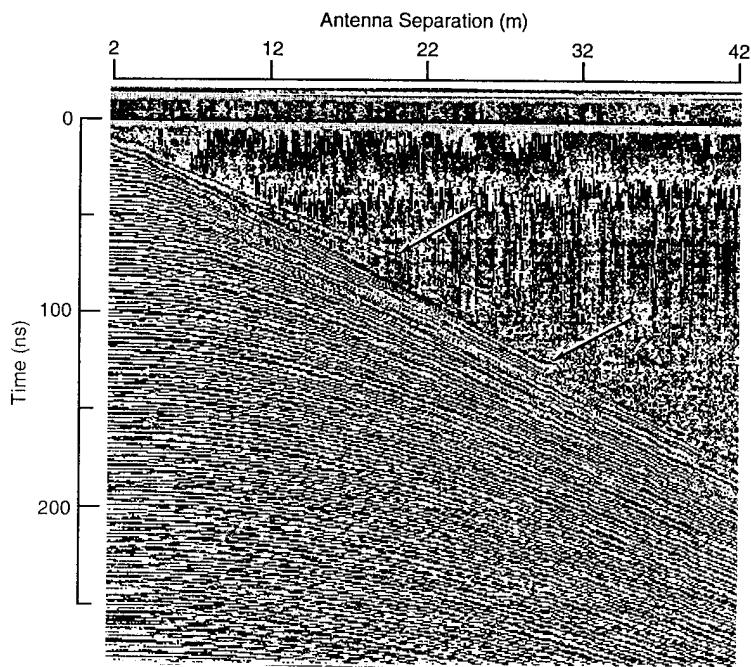
Figure 8. Wide angle reflection and refraction profile performed at about 400 MHz near the OCAF. Arrow 1 points to the directly coupled air wave, followed by the directly coupled ground wave (arrow 2). All other events become parallel with the ground wave. The slope of the ground wave corresponds to $n = 1.28$, equivalent to an approximate snow density of 0.33 g/cm^3 . Bright spots and noise bands are artifacts of the automatic gain control used to amplify the weak air wave.

The migration dielectric constant of 1.93 is an integrated value. The fact that ϵ increases with depth is demonstrated by the results of a WARR profile taken near the site (Fig. 8). The WARR used two Model 3102 units, one as a transmitter and the other as receiver; only the transmitter was moved. At the expense of noise amplification, automatic gain control was applied to this record to make visible the first event, the weak direct air wave coupling. The time-distance slope of the direct air wave coupling gives a velocity of 31.0 cm/ns , an error of about 3% over the actual value of 30 cm/ns . The ground wave slope gives a value of $n = 1.28$. This value of n corresponds to a near-surface density of about 0.35 g/cm^3 and, therefore, represents only the upper layers of snow. All subsequent subsurface reflections become parallel with the ground wave as they refract into the faster near-surface media; thus, refractions spend more time near the surface.

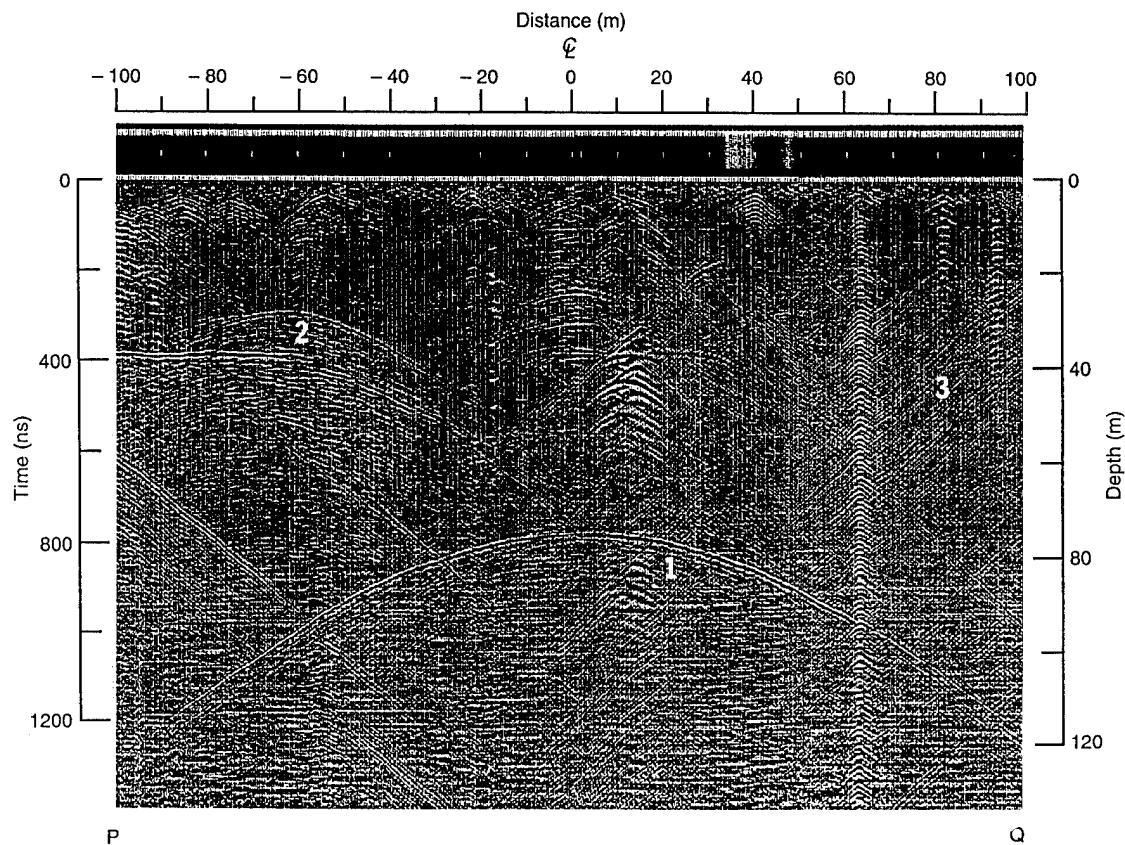
Figure 9. 100-MHz time section profile across the water well, the depth of which was 70.1 m. The asymptotic slopes of the hyperbolic diffraction from the well (1) give an $n_m = 1.59$; the slopes of the more shallow hyperbola (2) from an unknown object give $n_m = 1.46$; and the slopes of the resonant waves (3) generated by surface objects give $n_m = 1.36$.

A refractive index of 1.59 ($\epsilon = 2.53$) gives an almost perfect hyperbolic fit to this diffraction, and corresponds to an overburden average density of about 0.7 g/cm^3 . Alternatively, given the time delay and the measured depth to the water of 70.1 m, the effective refractive index for the firn overburden is determined to be 1.63 ($\epsilon = 2.66$). Although the estimated bulb diameter is 9 m, there is no evidence (e.g., two hyperbolae) of separate diffractions from each end of the bulb, as the temporal displacement of their asymptotes would be over 80 ns at the ends of the profile. Therefore, the diffraction itself, centered exactly at the center of the water well, is primarily a response to the complete well surface, but undoubtedly modified somewhat by the air bulb.

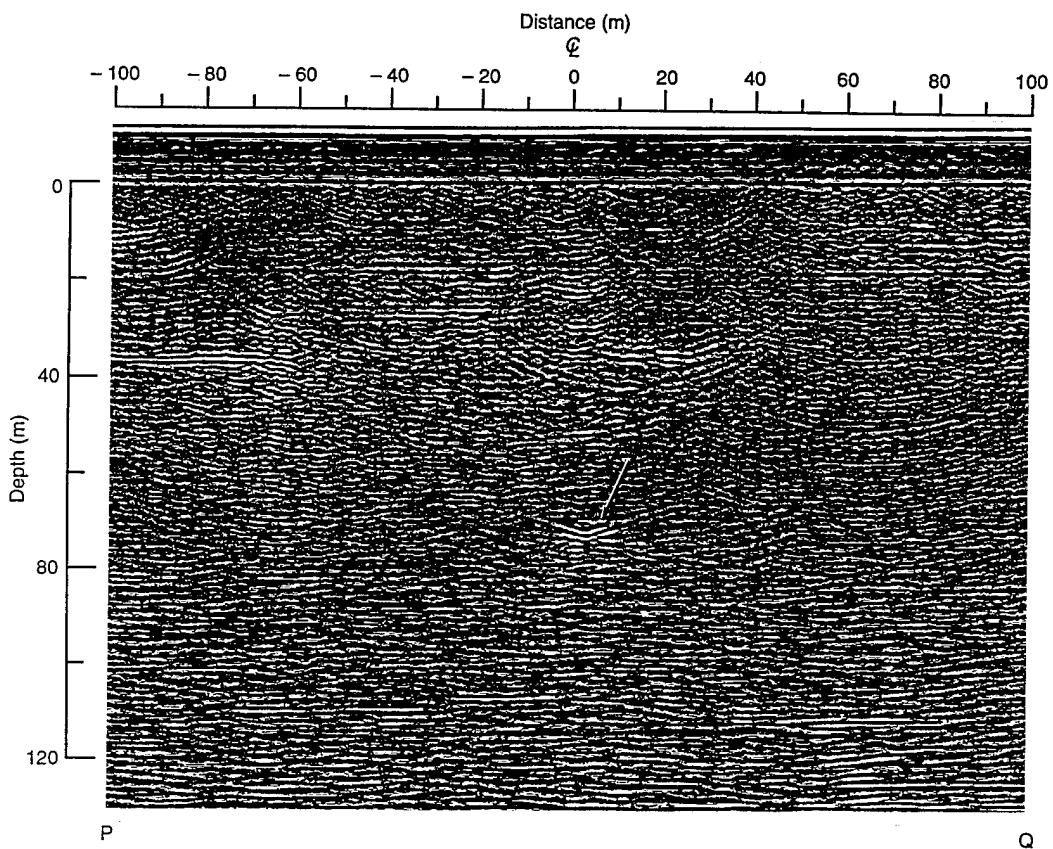
A migration of the water well profile is shown in Figure 10. The time section profile had to be compressed by a factor of two (subsequently expanded) so that the migration aperture could encompass most of the water well diffraction. The migration collapses the hyperbolic diffraction from the well to a segment approximately 16 m wide. This is wider than the estimated bulb diameter of 9 m and may be partly an artifact of the algorithm and the finite pulse width, as theory (Yilmaz 1987) shows that a perfect diffraction hyperbola generally collapses to this finite sized form rather than to a singular point. For estimating the encroachment of the sumps, we have assumed that the current diameter of the water well could be as great as 16 m.

Figure 10. Migration of the water well profile seen in Figure 9. The central bright spot at 71-m depth (arrow) is the water well and its width may be ascribable to a migration algorithm artifact because the diffraction is almost a perfect hyperbola and should migrate to a point. More shallow events in the profile are improperly migrated because of changing velocity with depth.

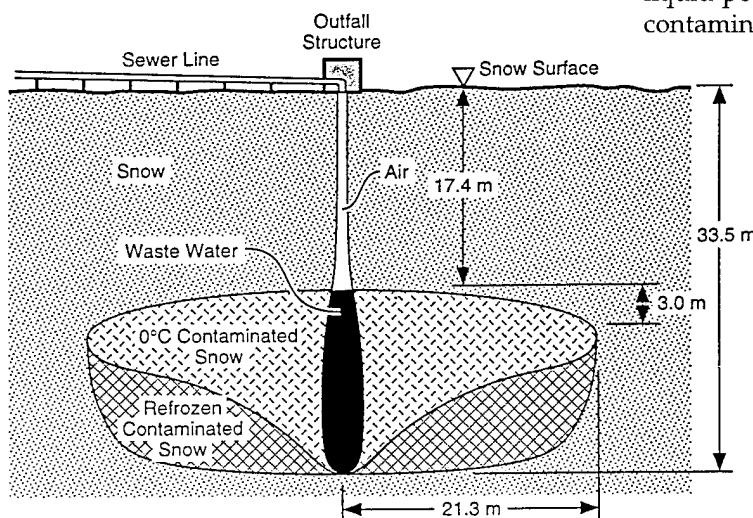
are marked in Figure 5. At the time of the survey, sump 1 was believed to look as depicted in Figure 11, which is based on prior CRREL and Metcalf and Eddy (M&E), Inc., measurements there and CRREL studies of similar sumps in Greenland. The surface of the central liquid pool was measured at

17.4 m below the snow surface during our surveys and the zone of sewage-contaminated 0°C snow was found the year before to extend radially about 21.3 m. At the extremities of the sump, the depth to the sewage-soaked material increases about by 3 m. This sump is in use and thus there is a central liquid pool and water in the upper portion of the contaminated snow.

Figure 11. Two-dimensional depiction of the disposition of sewage within sump 1 at location A in Figure 5.

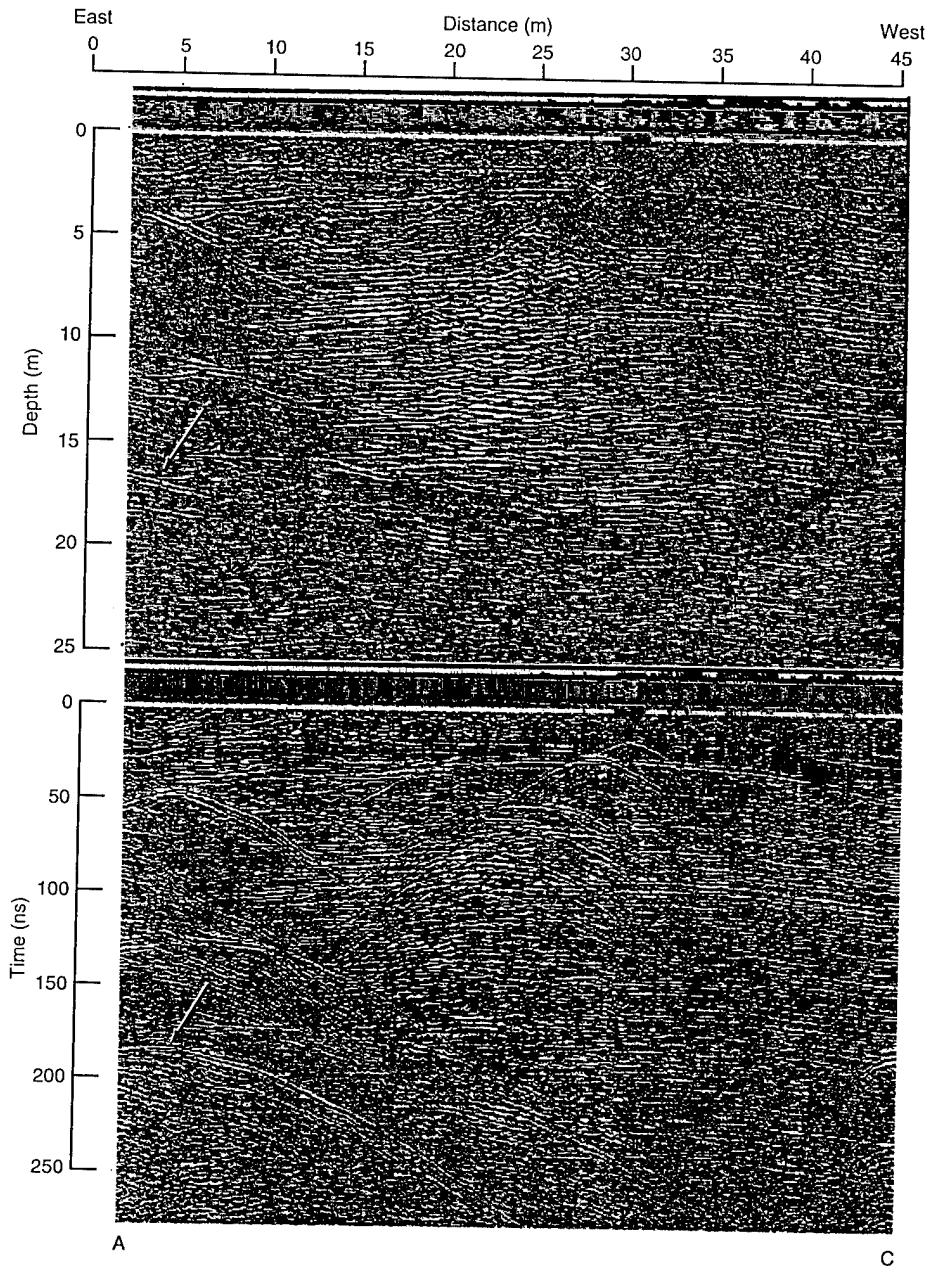
a. Line AC, which runs west from the sump 1 area. Arrows point to the response of the sump at a depth of about 17 m.

Figure 12. 400-MHz time-section profiles (bottom) and their migrations.

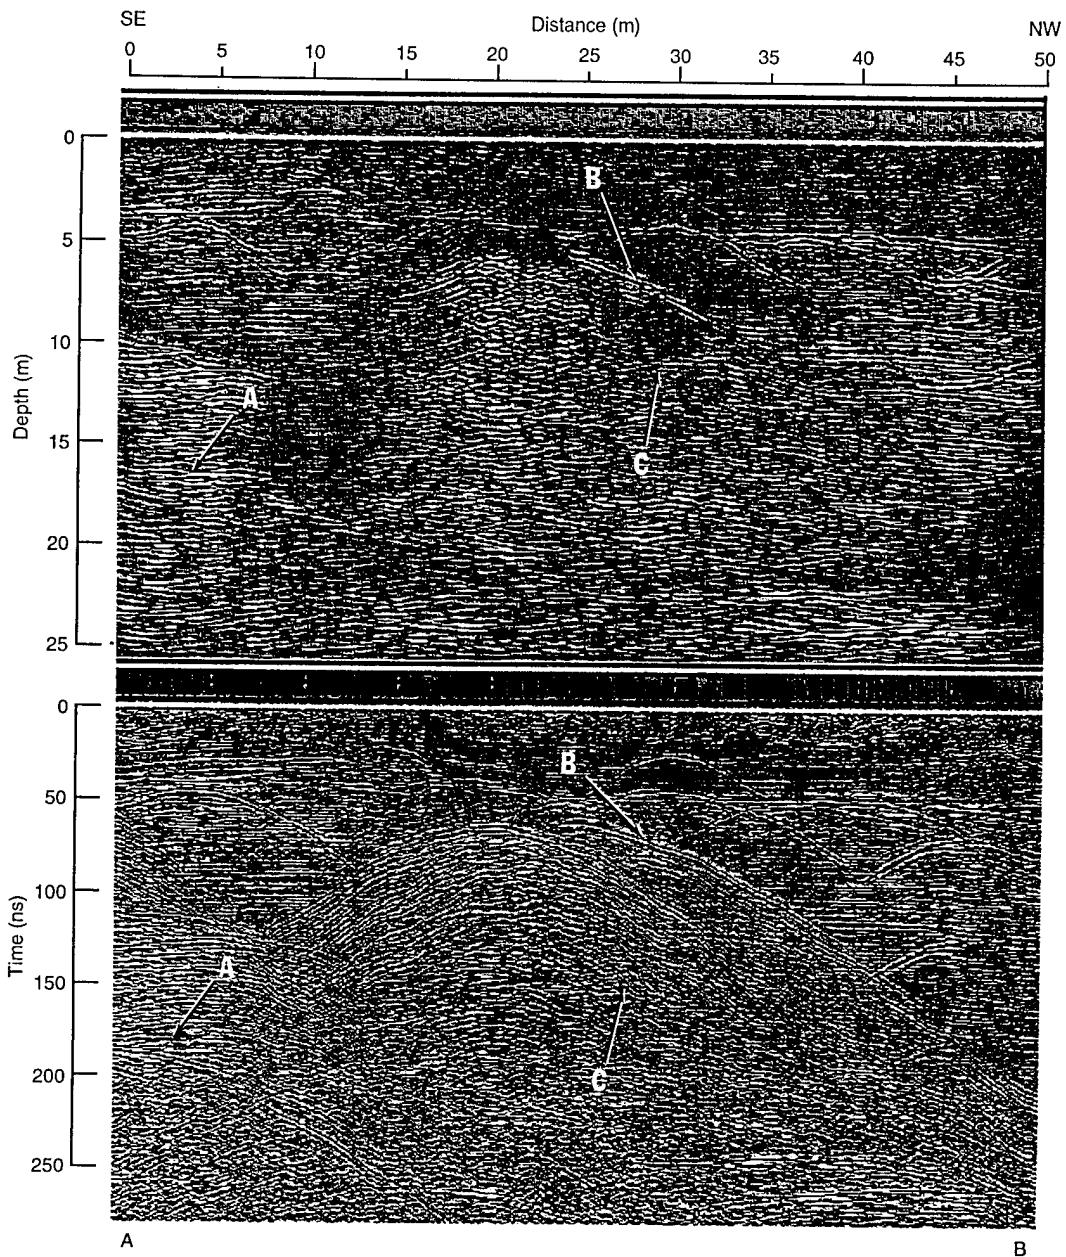
The time section profile in Figure 12b (bottom) along line AB starts at the center of sump 1 and passes near the utilidor vent at about 29 m and over the sewage sump centered about there. As shown in Figure 12a, the sump 1 response (arrow A) occurs at a depth of about 17 m and seems to extend only about 7 or 8 m northward. The diffraction response, which we believe is the utilidor roof

b. Line AB, which runs from the sump 1 to the utilidor vent in Figure 5. Arrow A points to the sump 1 response and arrow B to the probable response of the utilidor vent. The vent response migrates to a slope, which indicates increasing distance from the utilidor. The slope originates at 25 m and may indicate a positional error. The sump response at the vent is probably the diffractions indicated as C. The spread of sewage in both sumps suggested by the migration is believed to be far too small.

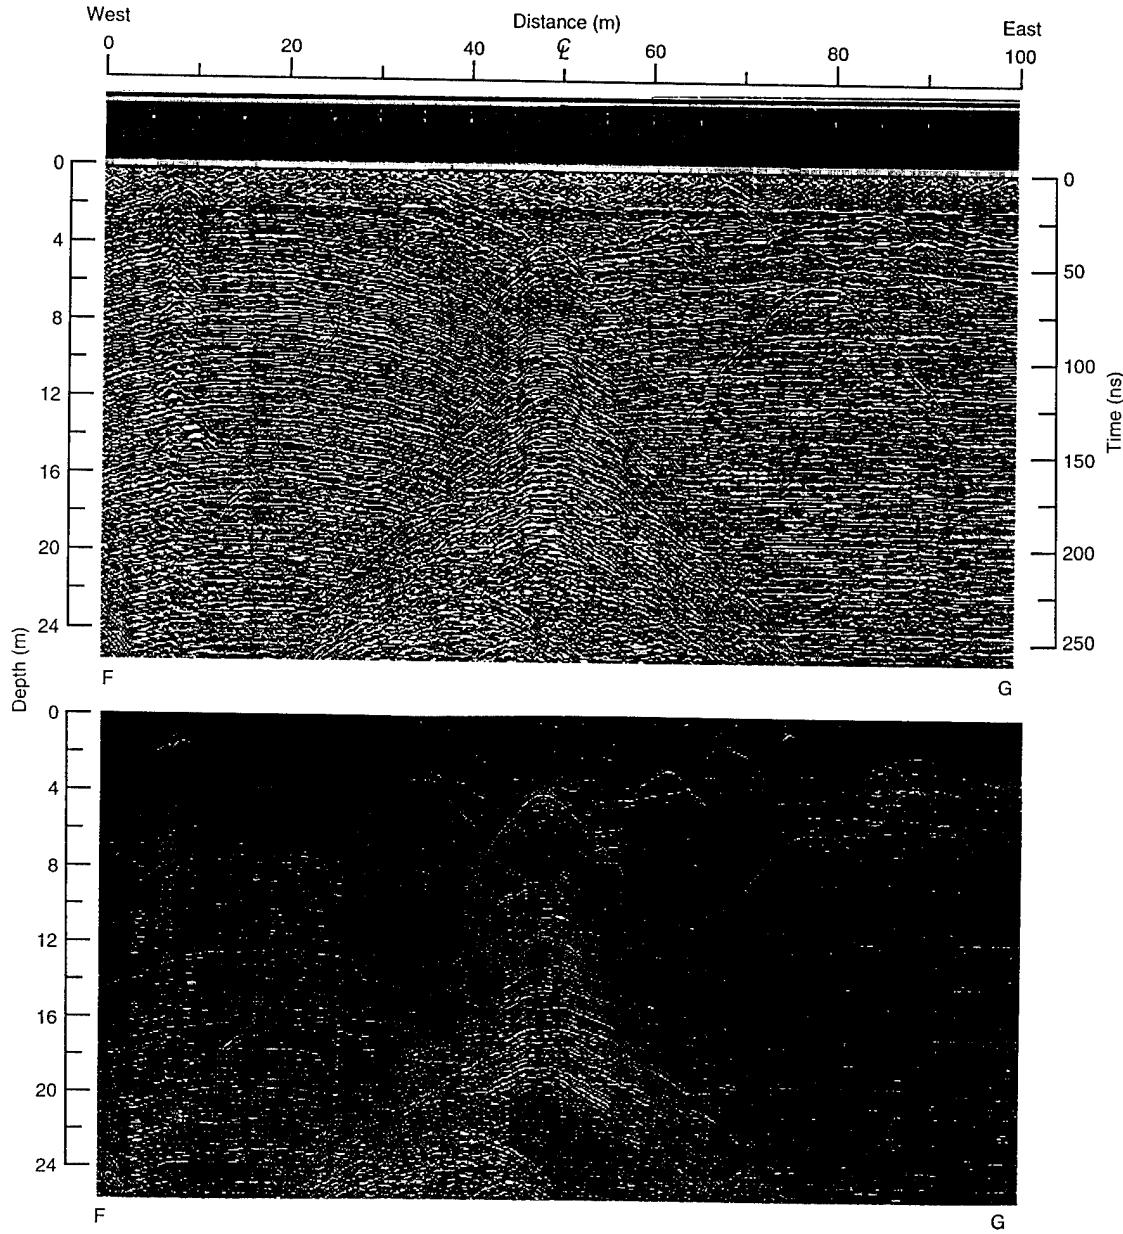
Figure 13. Two versions of the 400-MHz profile recorded at 300 ns across line FG over sump 2. The sump is centered at the 50-m distance. The bottom profile represents an estimate of the actual reflective strength throughout the sump and shows greater diffraction intensity below 12 m where frozen sewage begins. The later diffractions are strong enough to make their asymptotes visible. The top profile equalizes the intensity of all events and reveals the density horizons that subside toward the sump.

The top profile of Figure 13 equalizes the gain throughout the record so that all events are equally apparent, especially those from the density contrast interfaces, which appear to subside toward the sump. This subsidence is consistent with known increases in snow consolidation from warming in the vicinity of such sumps. Snow consolidation is also apparent from the refractive indices measured at sums 1 and 2; the values of 1.5 to 1.6 over the 16-m depth are higher than maximum values (1.4) found over similar depths along the tunnel survey.

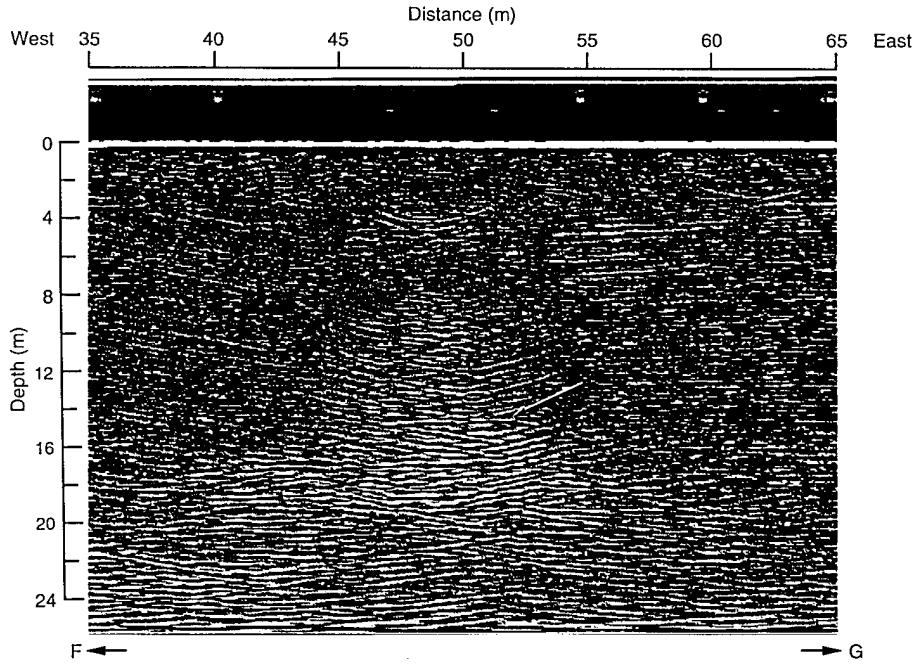
A migration of the central section of this profile is shown in Figure 14. Some of the peak signal strengths along the profile scans are amplified to bit saturation to allow us to view the deeper returns. The migration shows a coherent horizon at about 14 m depth and then reflections that spread asymmetrically to an approximate width (diameter) of 25 m at a depth of about 16 m. The sump 2 region seems to extend about 15 m to the west, but this sump is known to be refrozen and to extend radially about 20 m towards the water well. Therefore, we conclude that the contaminated firn beyond a 15 m radius did not produce detectable reflections.

Figure 14. Migration of the central section of the sump 2 profile using a migration velocity based on $n_m = 1.54$ (density 0.65). The section indicates that the sewage spreads to an estimated width (diameter) of 25 m, 15 m of which is towards the water well. Arrow points to a coherent reflection at about 14 m depth.

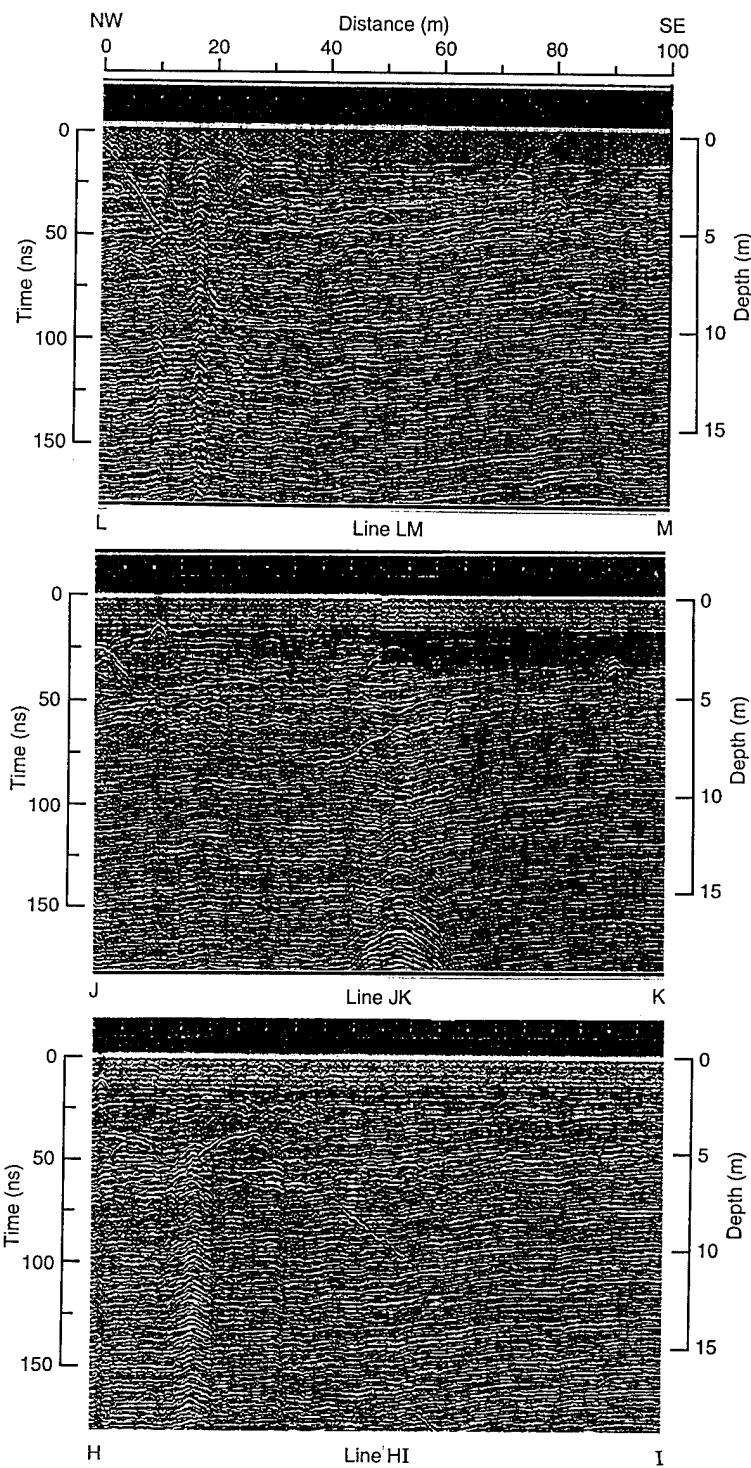
Figure 15. Three parallel 400-MHz profiles recorded at 200 ns at the far sump location (lines HI, JK, LM in Figure 5). Only line JK picked up diffractions at depth.

those seen around sump 2 in Figure 13 and is further evidence for firn subsidence around the sums. None of the diffractions originating near 12 m depth are of unusual intensity, but at the 16- to 17-m depth, the diffractions become more in-

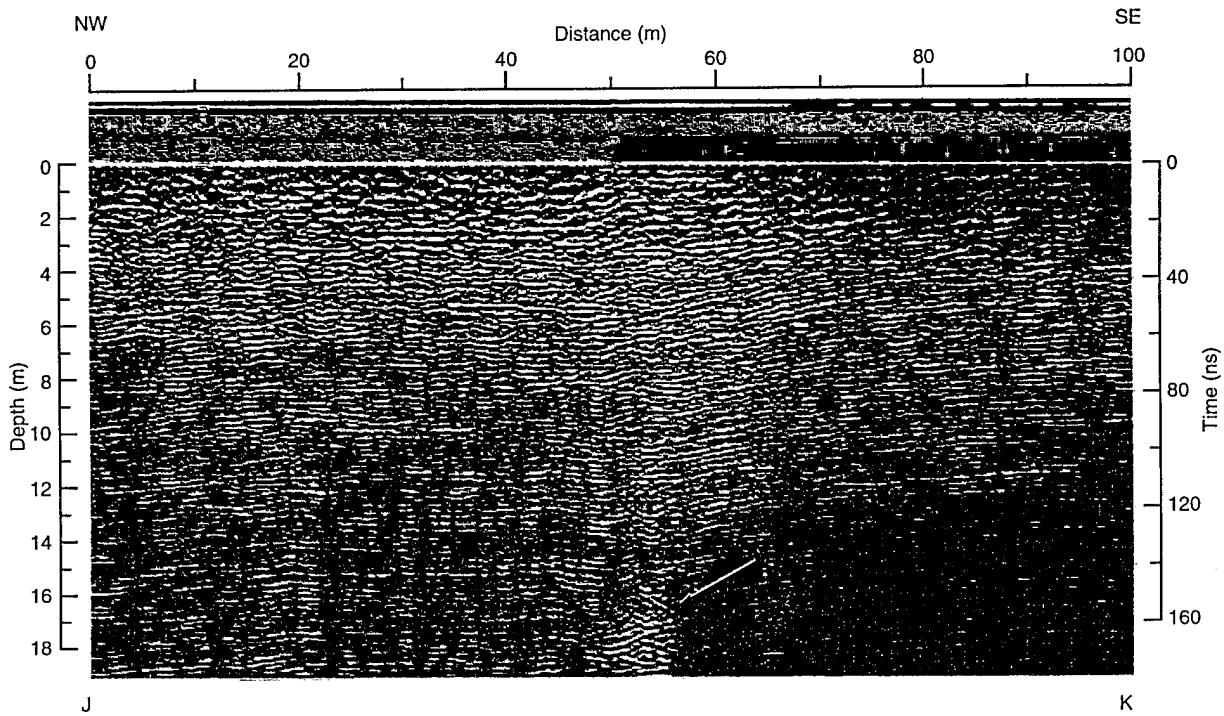
Figure 16. Migration of the profile along the centerline JK at the far sump. A concentration of sewage beginning at about 14 m depth is apparent, but there is no indication of the lateral spreading reported to exist.

tense. The migration of this record (Fig. 16) picks up these deeper targets, which probably represent layers of contaminated snow deeper in the sump. The radar records again suggest less lateral spread of contamination from the discharge point than the 21 m estimated by M&E.

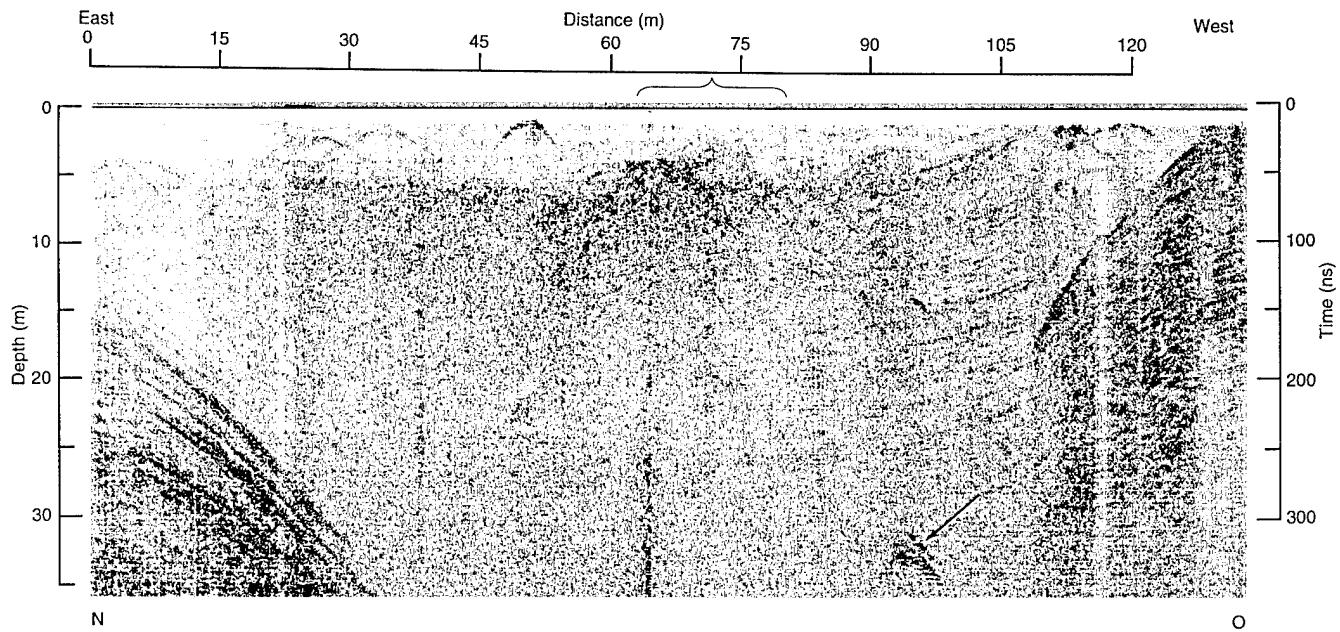
Several diffractions occur between the sump and utilidor that could be leaks along the sewer line. Although not easily visible in Figure 17, a cluster of weak diffractions between 64 and 80 m are candidates for shafts caused by leaks. The diffraction at 30 m depth about 93 m from N may be frozen sewage at the base of such a shaft.

Figure 17. 400-MHz time-section profile from the center of the far sump (point N) back toward the lift station. The diffractions beginning at about 15 m depth at point N are responses to the frozen sewage, but there is no indication of the lateral spreading previously reported because all these diffractions originate near point N. The bracket spans a cluster of weak diffractions whose depth indicates that they may be an old sewer leak, and the arrow points to a deep anomaly of unknown origin.

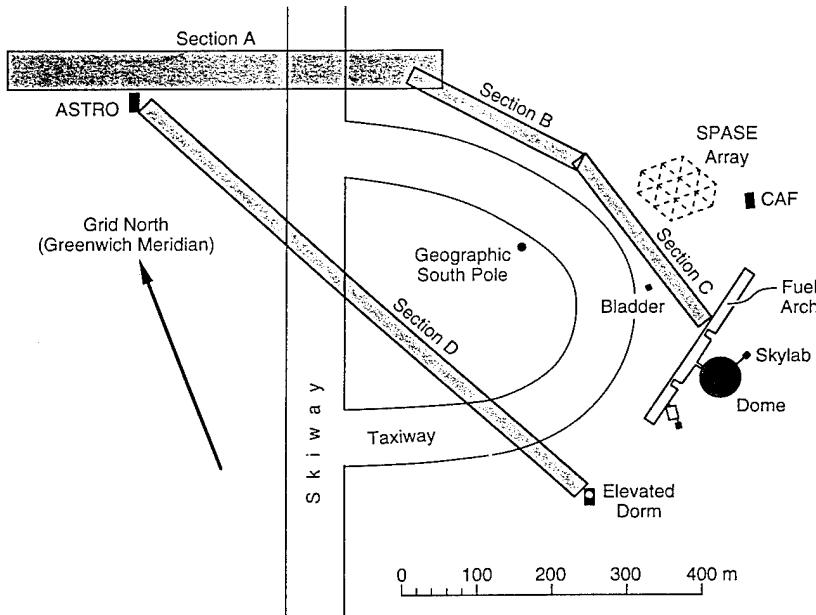
The two tunnel routes studied are shown in Figure 18. The upper route is divided into sections lettered A, B and C. So much buried debris was detected within the section A survey (originally 30 m wide) just west of the skiway that the width of that section was increased by 10 m to the south and 20 m to the north. Section D in Figure 18 is a narrow swath surveyed between the ASTRO facility and the elevated dormitory. All surveys consisted of parallel profiles, about 2.8 m apart, running the length of the sections. The profiles are alphabetically lettered and may be located later in Figures 21 and 22.

Figure 18. Proposed tunnel routes. Sections A, B and C run from the dome to the ASTRO and CARA (under construction) astronomical facilities. Section D is a 10-m wide section that extended 800 m from the ASTRO building to the elevated dormitory across the skiway.

Scattered debris west of the ASTRO building is located at depths that will cause it to interfere with tunneling. However, safe routes through this area are possible. Our route surveys enabled us to find debris and assess the suitability of tunneling routes, but that work was not conducted to pinpoint the location of each potential problem. An additional radar survey for that purpose will be needed just prior to tunneling.

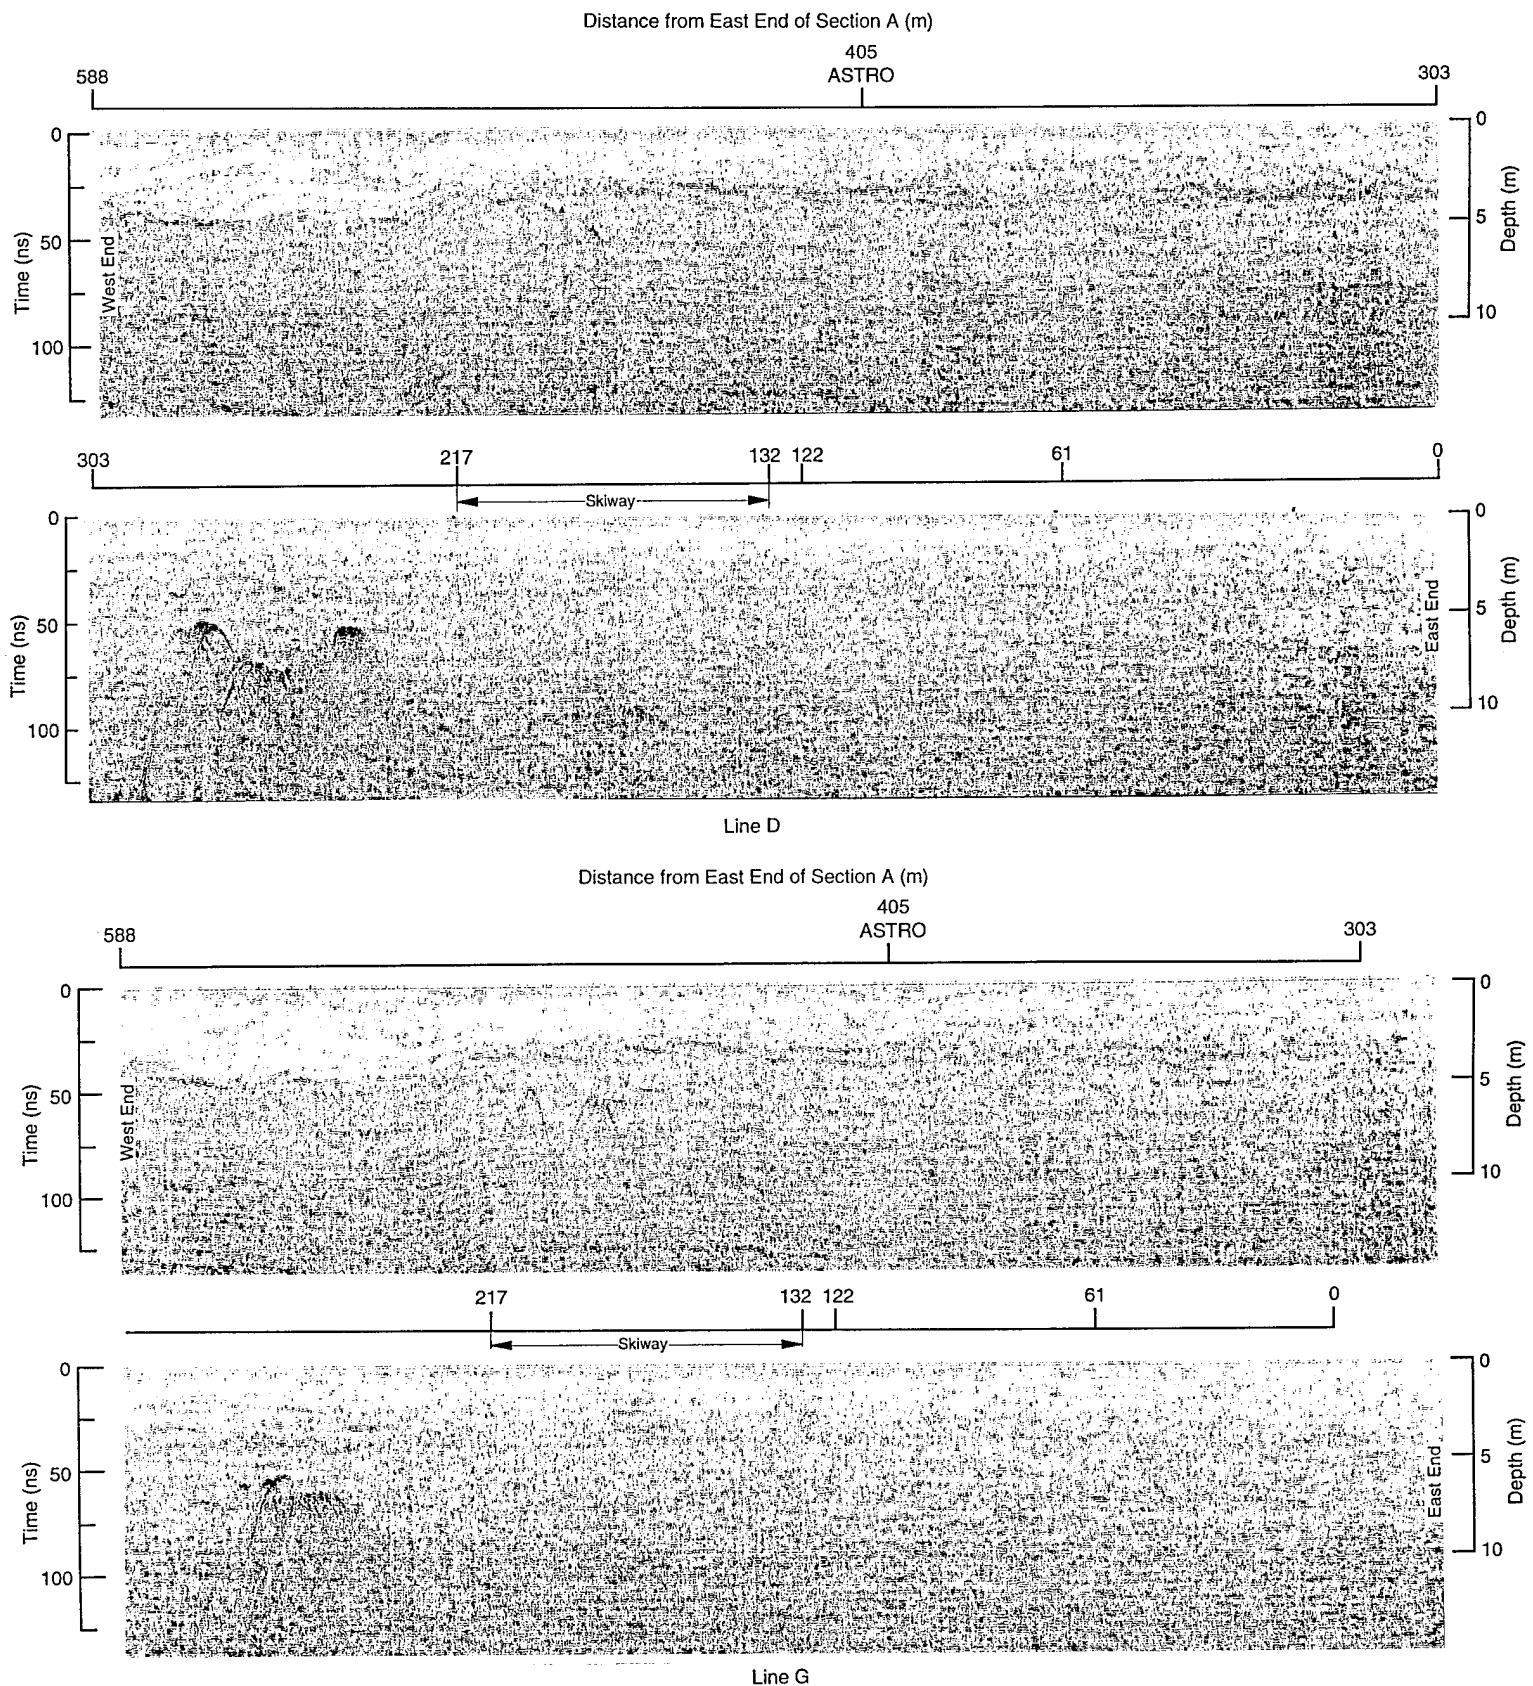
the stronger events. Both profiles show a heavy concentration of diffractions just west of the skiway. This concentration is characteristic of most profiles in this section and is the most formidable obstacle in the tunnel survey. Further to the west

Figure 19. Profiles of lines D and G along section A of the tunnel survey. The depth scale is based on $\epsilon = 1.93$. Many hyperbolic diffractions can be seen just west of the skiway. A horizon at 4- to 5-m depth is the work surface from previous operations at the first pole station established in 1957.

beyond the ASTRO complex several solitary diffractions may be seen. The location and depth of all these diffractions are plotted later in Figure 21. Also visible in Figure 19 is a horizon at about 3 to 4 m depth. This is believed to be dense snow caused by traffic between the old and new stations during the early 1970's when the new station was being constructed.

Debris just west of the skiway along the tunnel route initially proposed between ASTRO and the main station appears to be large and extensive. The tunnel should be routed just north of this area. A few objects exist in the snow along this new route, but a tunnel route can be found among them with the help of radar.

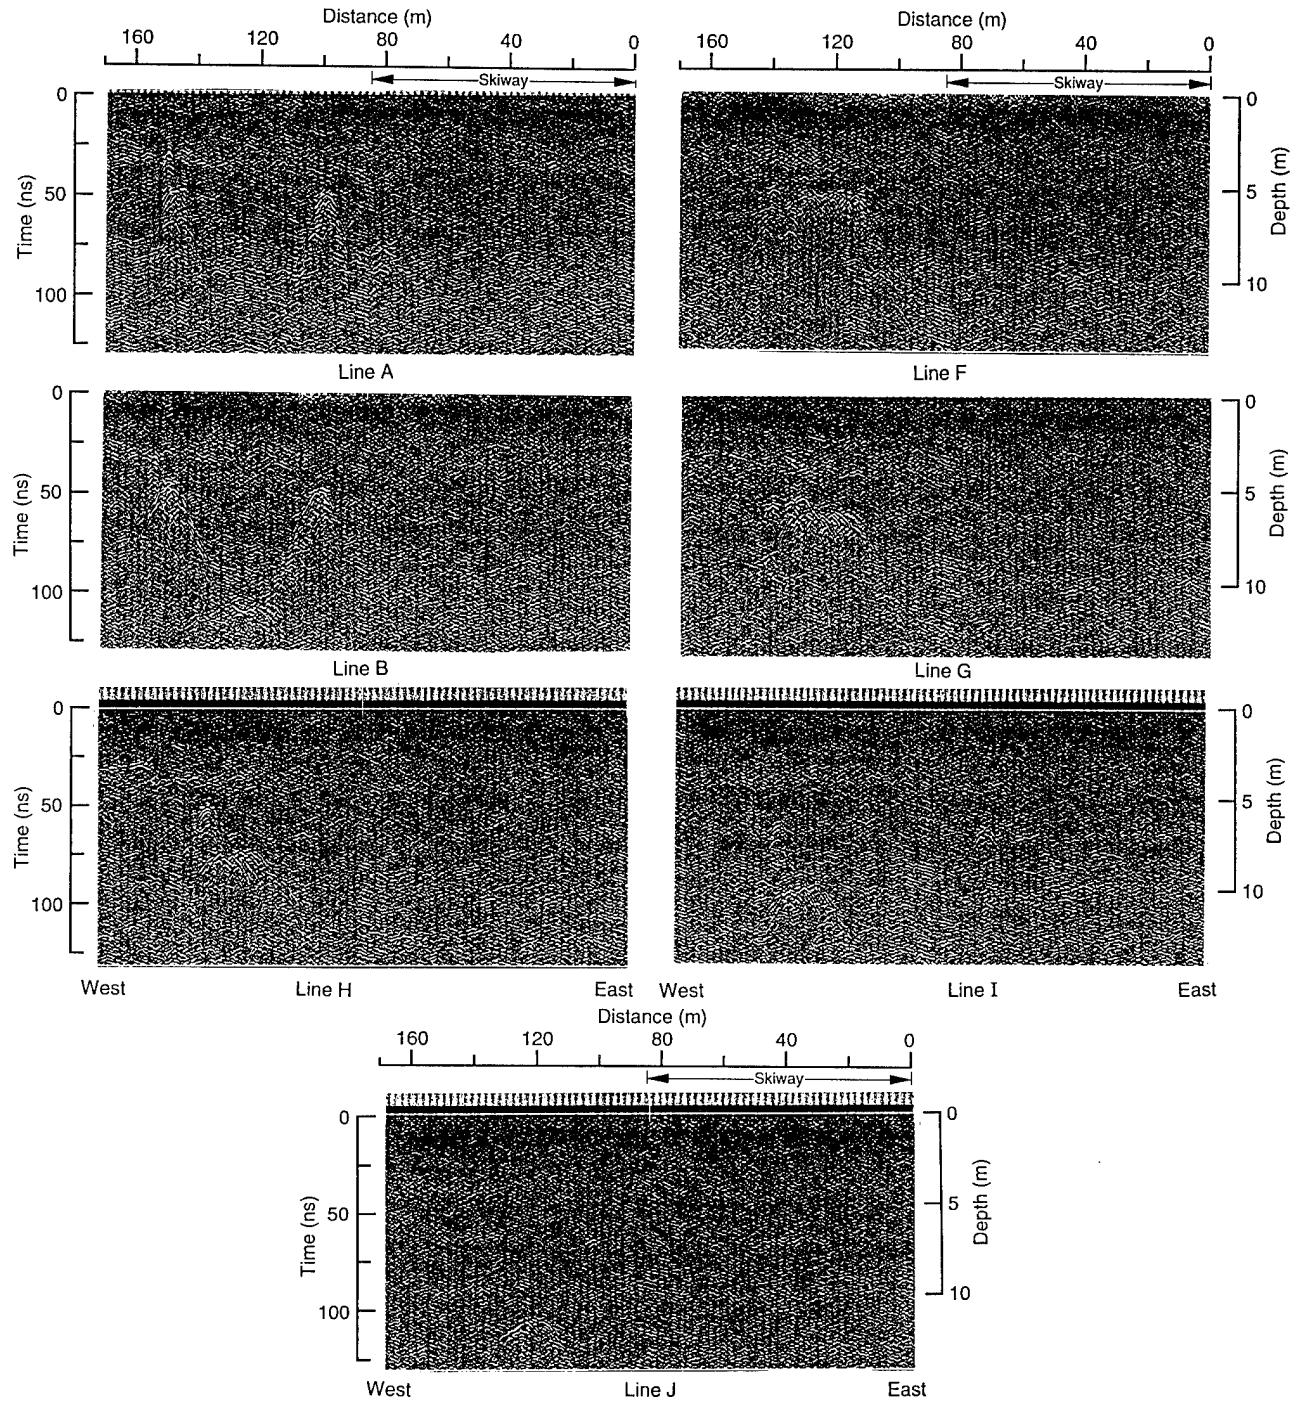
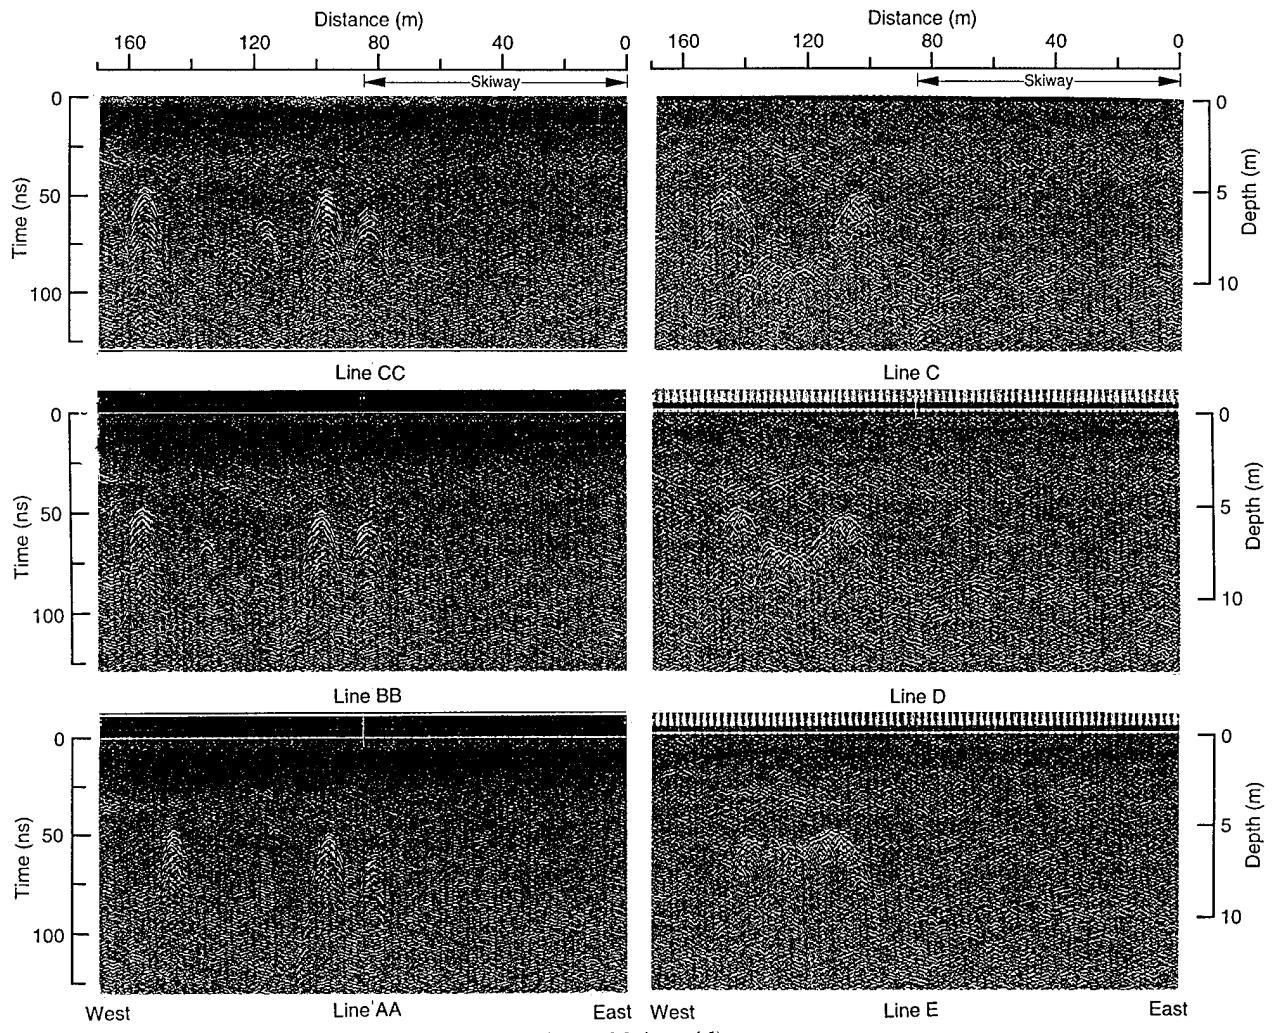
Figure 20. Segments of lines CC–J that contain the many diffractions west of the skiway. The apexes of the diffractions rise as the transects progress to the north (toward line J).

All radar profiles from line CC (southernmost line) to line J contained diffractions, with most concentrated in the 85-m-wide strip just west of the skiway. No diffractions were seen along lines K through Q in this 85-m-wide area. These 85-m-long profile segments along with the skiway itself are shown in Figure 20. Lines CC through A show responses from distinct targets. The re-
